## **Inspection with Polish authorities of a poultry truck with spent- laying hens from the Netherlands**

**Date:** 20.04.2016

**Location:** A2 highway near Poznan, Poland

Poultry- truck owned by Zakład Drobiarski „Lech Drób” Sp. z o.o.;  
Registration number: NIL 28211,  
Make: Wielton.

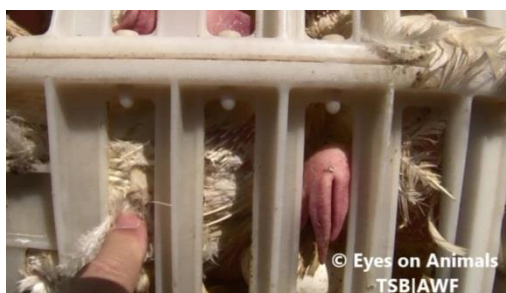
- *Fitness for transport:* many animals made a very poor impression. Numerous were observed already dead. (see video footage)
- *Density:* Unnecessary pain and suffering during the journey because of exceeded loading density. The birds had problems keeping their natural position because there were too many of them in one cage. (see video footage and photos below)

- **DOA:** according to the slaughterhouse veterinarian at the destination, the total number of birds dead on arrival was 93 (over 1% of DOA's).

Dead birds

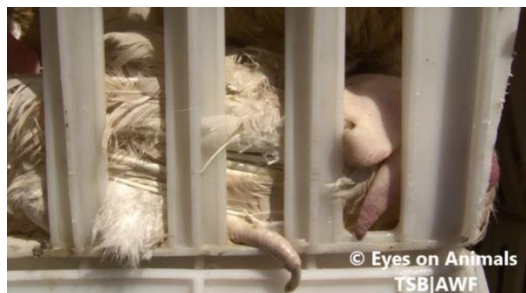
Dead spent laying-hen

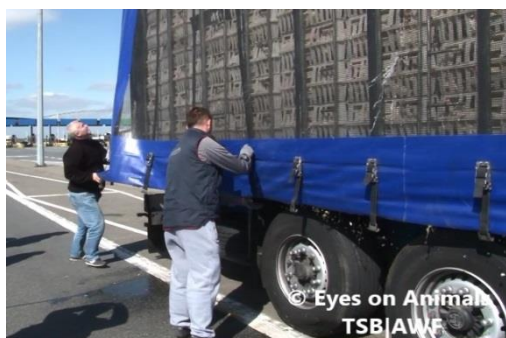
Curtains: appropriate for poultry transport, installed and properly attached.

Appropriate curtains in place

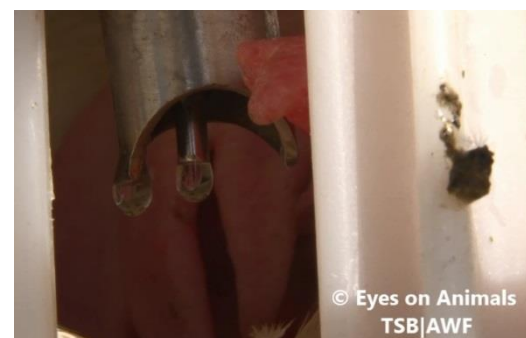
A generally modern truck with watering system for poultry. We could only see the watering system for external rows of cages, the drivers said there is a watering system for the middle row as well. Unfortunately, after asking the drivers to turn the water on, we saw that the watering system on the right side was leaking at about two thirds of the length of the truck, which means that birds in the back one third of the truck were transported without water supply. (see video footage).

- *leaking watering system* on the right side of the truck, meaning lack of water supply for the birds in the back of the truck. We could not inspect the watering system in the middle row of cages. (see video footage and photos on next page).

Leaking water system
