Inspection of loading of spent hens at a farm near Lunteren, The Netherlands (9-10.04.2013)

---- External report ----

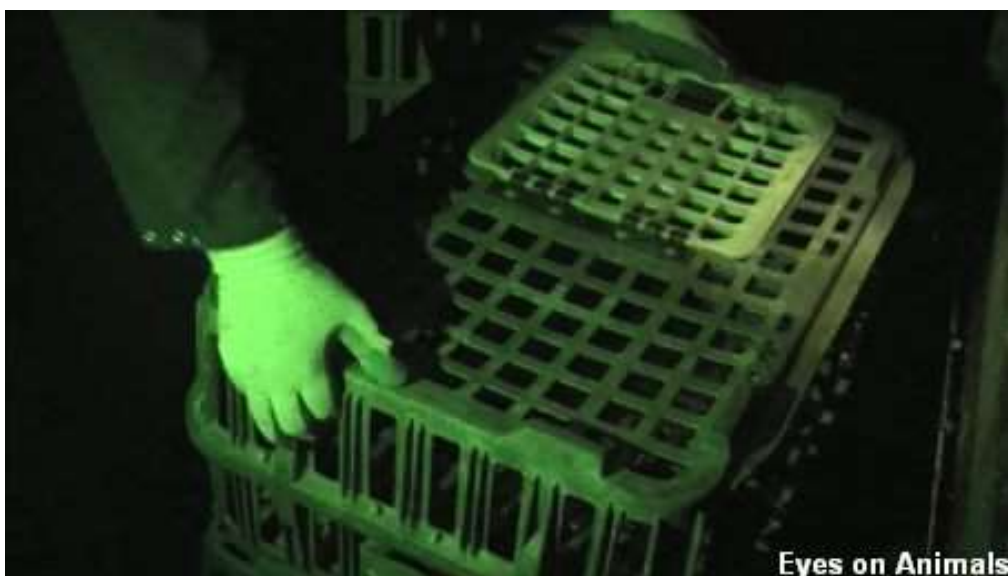
These particular crates have very small loading doors at the top of the crate..

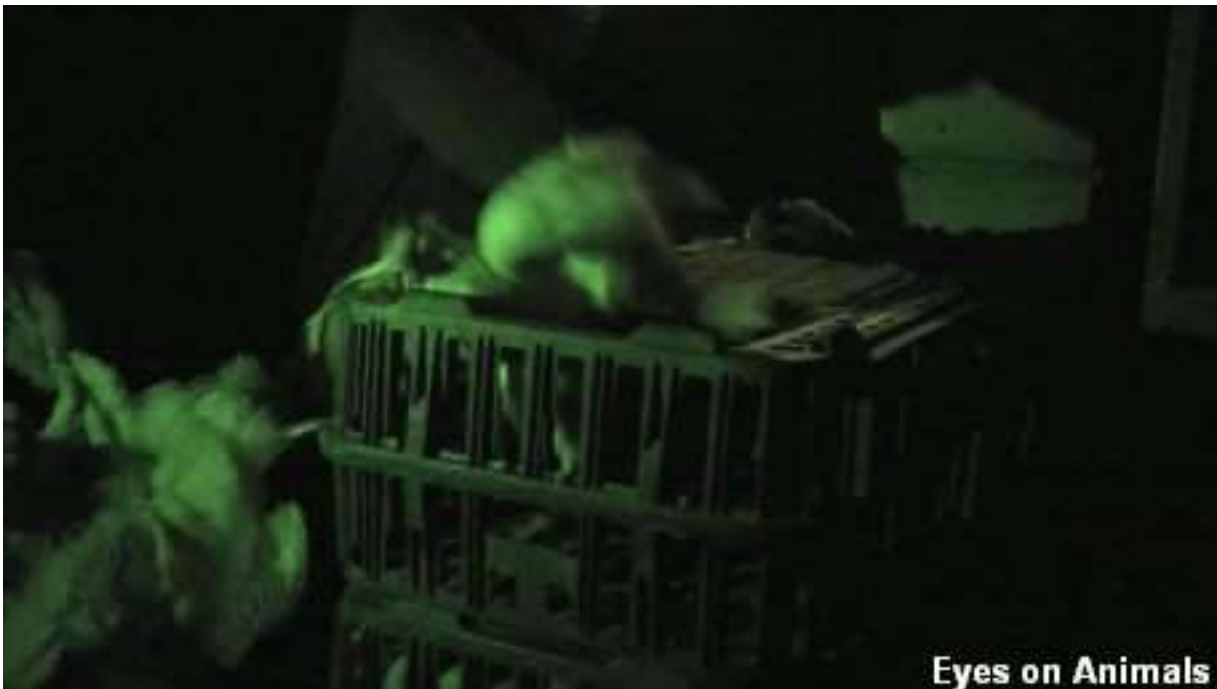
The catcher passes the birds, 4 at a time, to the loader.

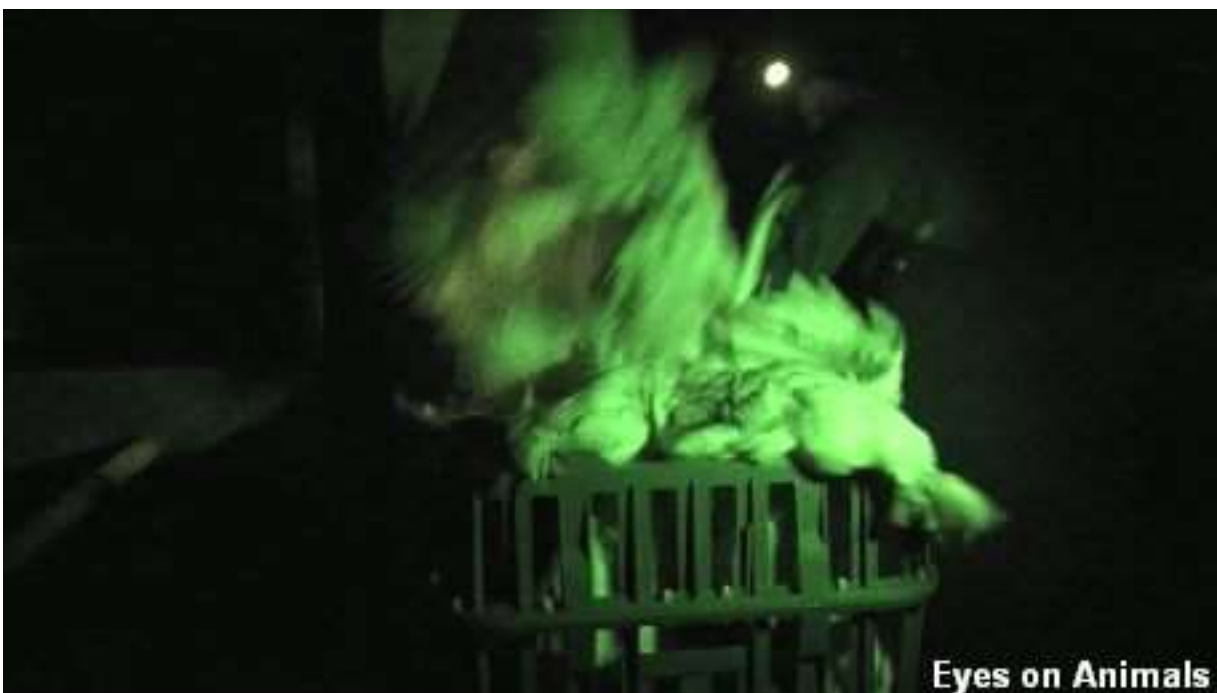
The loader then “stuffs” 4-birds at a time through the small entrance of the transport crate.

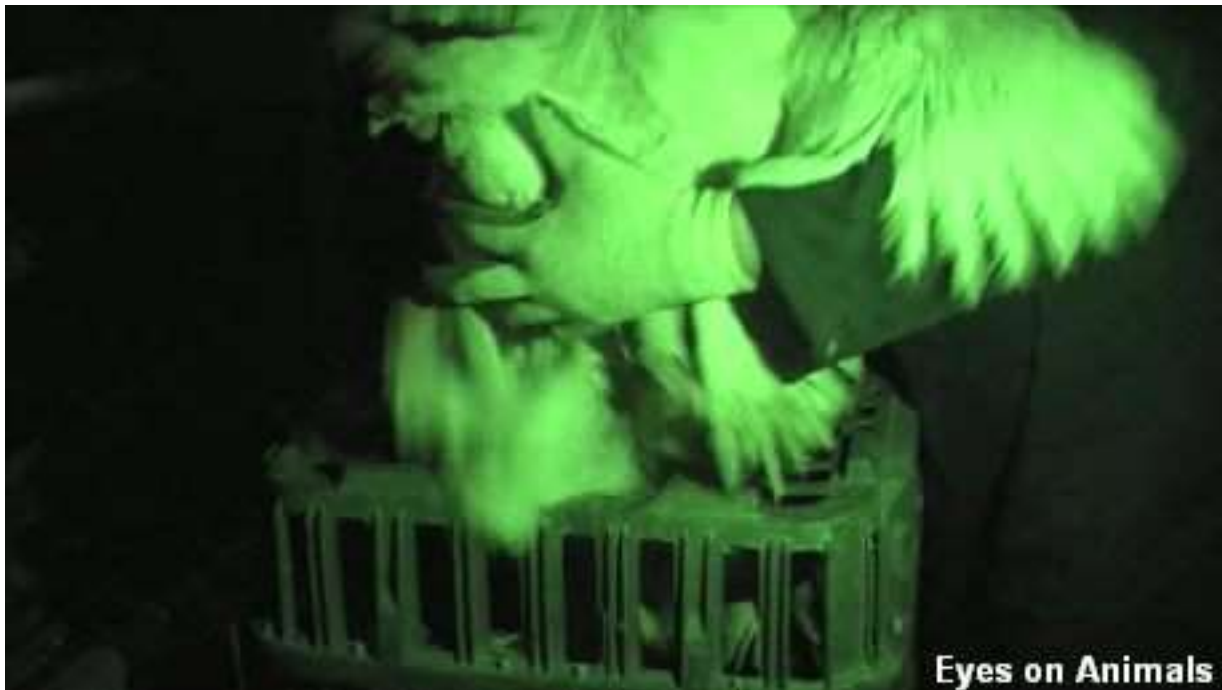
The birds in the aviary are all making some sound, due to the excitement of what is going on. But what we definitely notice is that as soon as the group of 4 birds hit the entrance of the crate, their screams go up a notch. We notice that many get their feet, head or wings caught at the entrance of the crate door, as the group of 4 are too large to pass into this small space all at the same time. This increase in crying is likely due to the pain they feel when stuffed into the door. It is at this point of the loading process that we fear fractures to limbs are taking place. This may also explain why so many spent hens arrive at the slaughterhouse with fractures.

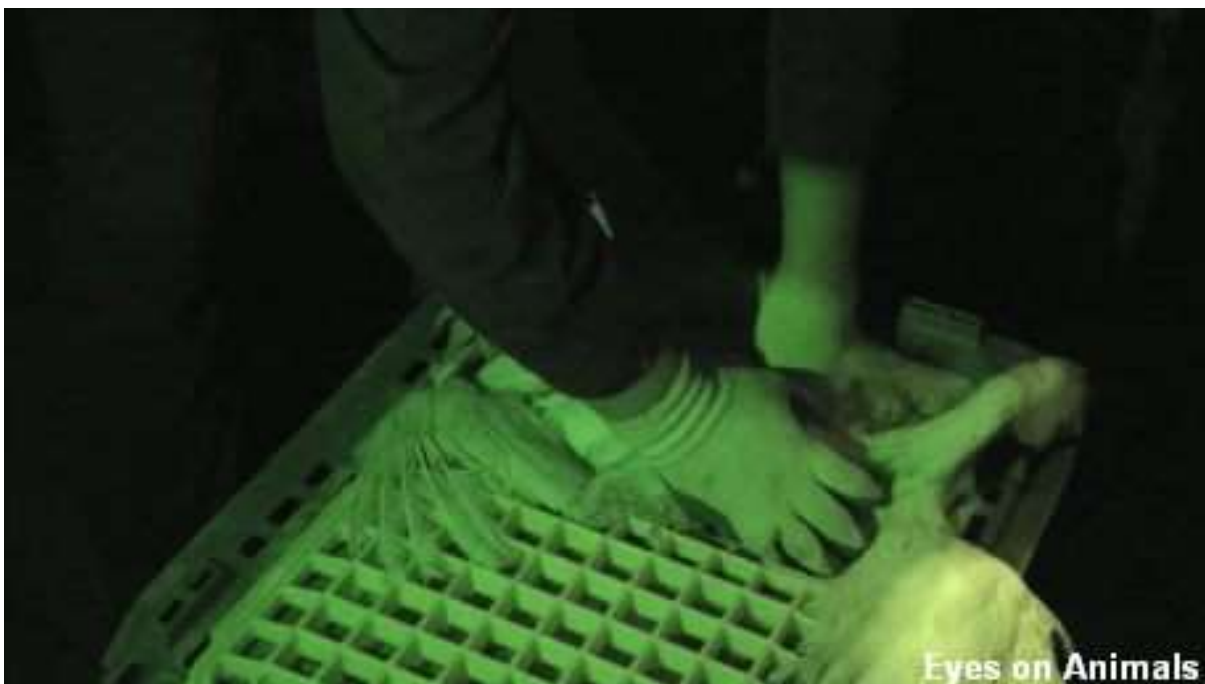
Sometimes the entire wing was hanging out of the loading door. If the worker is careful and takes time, he should gently fold the wing back in. But often there is not time to be careful with each bird...

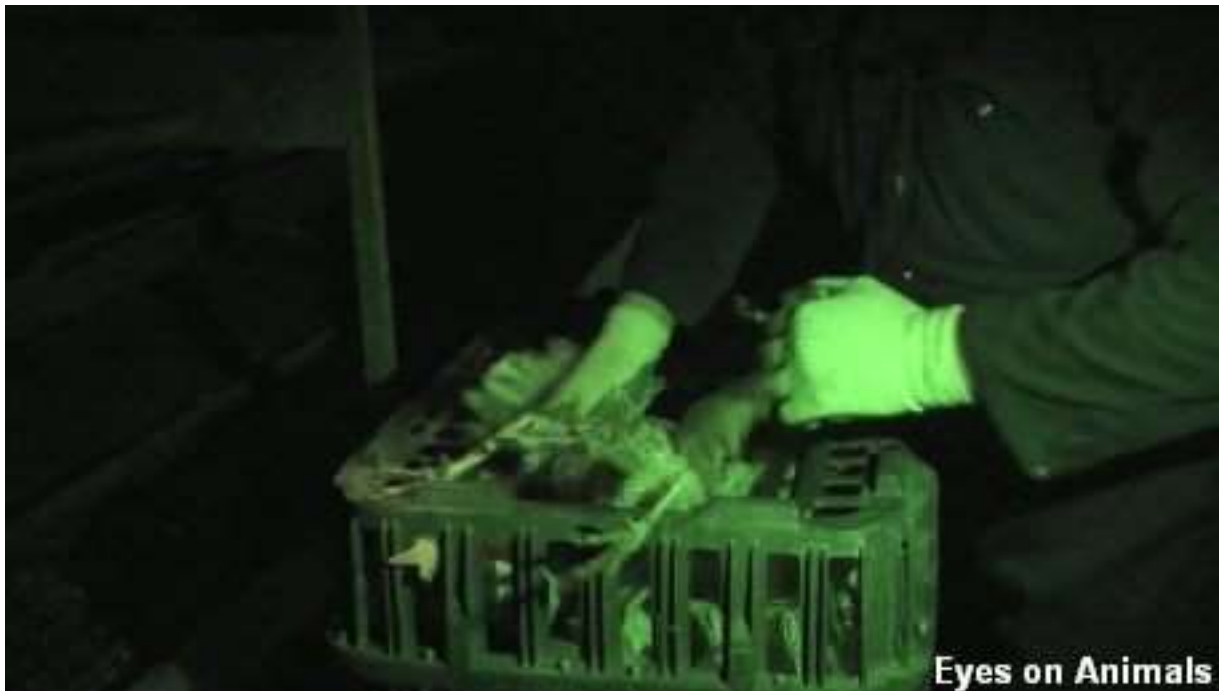
Legs also get caught sticking out of the crate, in all sorts of unnatural directions, while the loader tries to stuff all 4 in at a time.

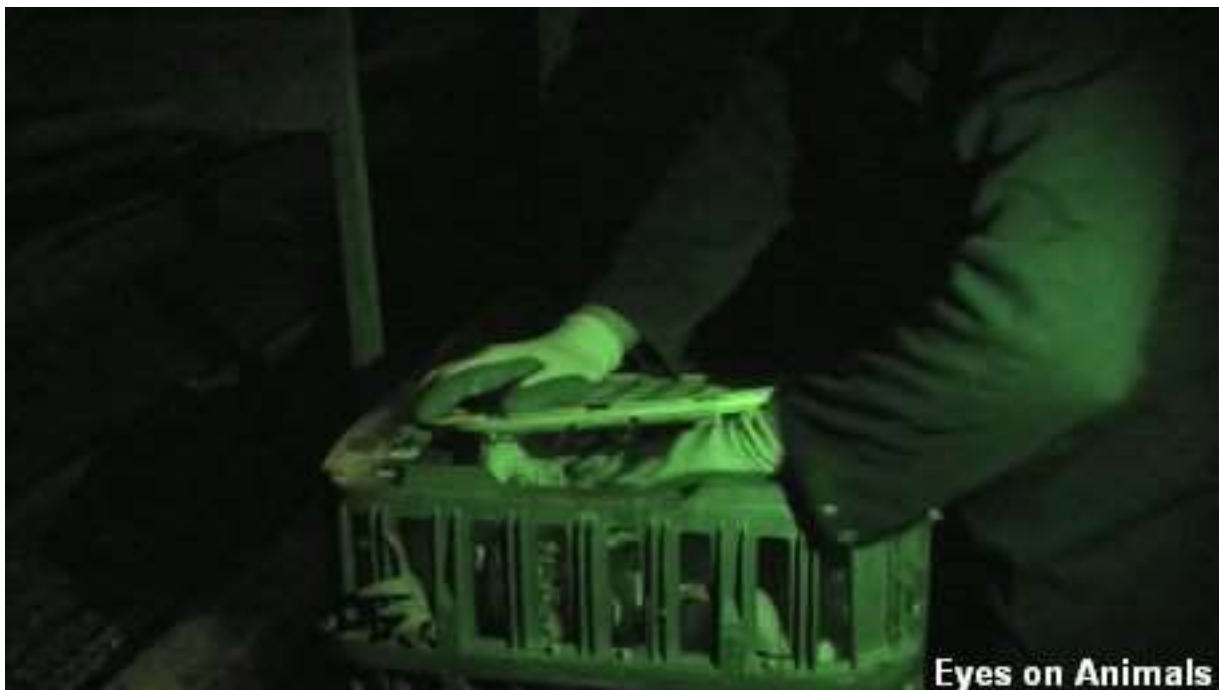
This loader was good, placing his hands over the birds to be sure no limbs or wings or heads were sticking out, before slamming the crate door shut.

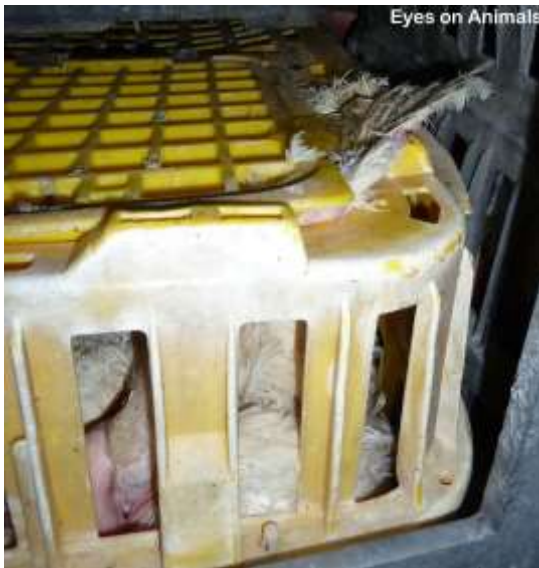
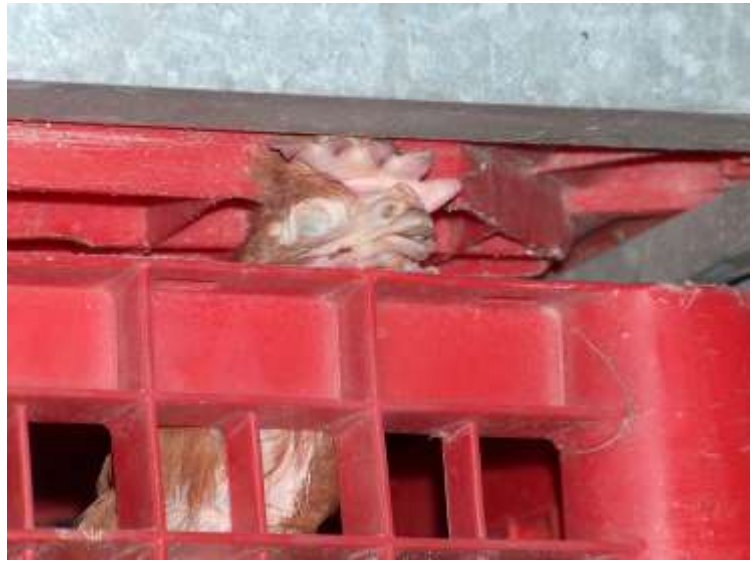
Sadly, this was not the case for these birds, that Eyes on Animals and PMAF observed during other inspections (left in The Netherlands, right, in France).

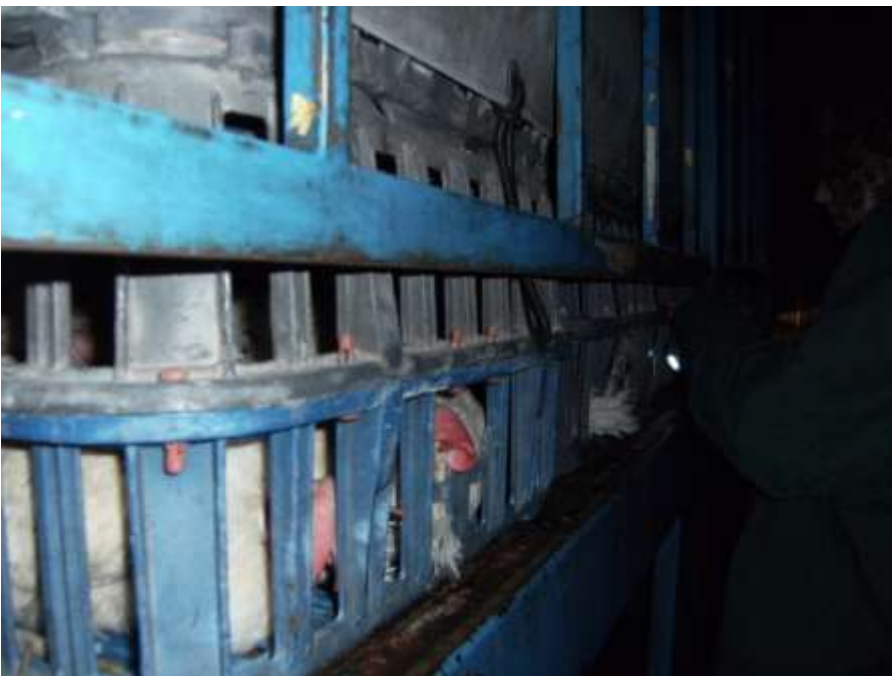
It is cold outside, roughly 6 degrees Celcius. The tarps are on, but the bottom crates are not covered by it as they are not long enough.

The birds on the bottom row are not protected from the cold wind, as the tarp is not long enough.

(b) protect the animals from inclement weather, extreme temperatures and adverse changes in climatic conditions;

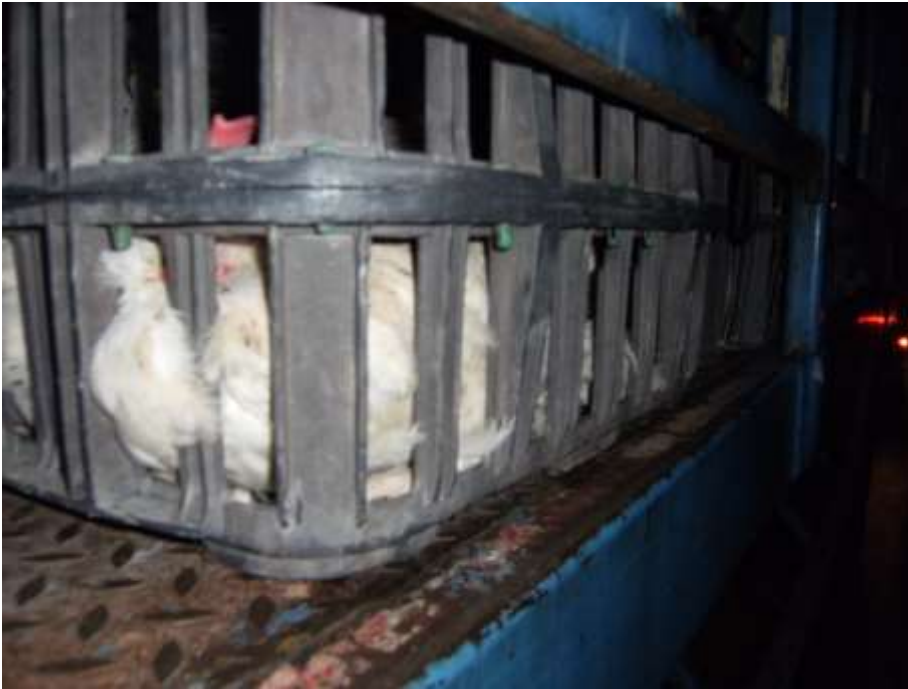
The driver explains to us that Wilki now at least replaces all broken crates with new ones. The crates are inspected regularly upon arrival at the slaughterhouse. Crates that have many broken parts are thrown out and new ones ordered. This is something Eyes on Animals worked on with Wilki last year. We are happy to see that they took action on rectifying this problem.

Wilki crates 09.04.2013 (we did not notice any seriously broken ones, many on the truck looked new)

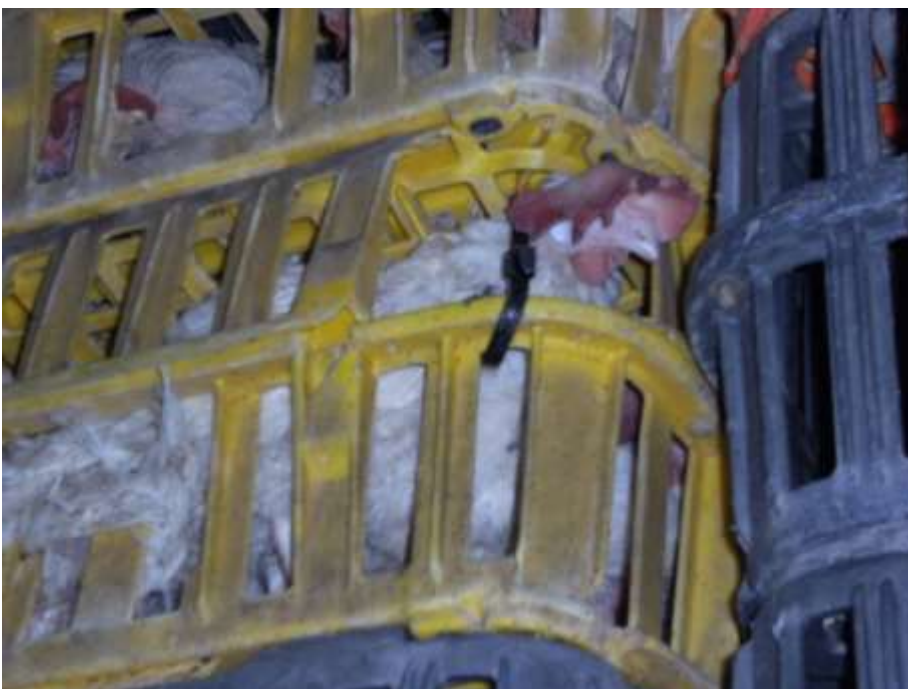
Wilki crates seen by Eyes on Animals during an inspection in 2011 on the highway in the Netherlands.
