Trailing of spent breeding hens and roosters from the Netherlands to a Polish slaughterhouse

---External report---

Summary: On May 14th 2013 a team from Eyes on Animals and Animal Welfare Foundation was on the roads of the Netherlands to conduct random checks of livestock trucks. At a poultry farm in Brabant several trucks were seen being loaded with spent breeding hens and roosters. The transport company, Van der Berg, is known to bring poultry on a regular basis to Poland so we decided to trail one to record total length of journey and if possible check on the condition of the animals and the crates. Trailer Licence OK 20 PZ. Total driving time was 12.5 hours, loading time was approx.. 2.5 hours and waiting time in lairage at slaughterhouse up to 4 hours for some birds. The birds were crowded but upon calculating the density it was, surprisingly, within the EU norm. The crates were not equipped with a water system. As the wind-protection tarps were up, we could only check on a few birds. We were not allowed into the slaughterhouse but the official veterinarian met with us after and had the details of the consignment faxed over from the slaughterhouse to show us everything.

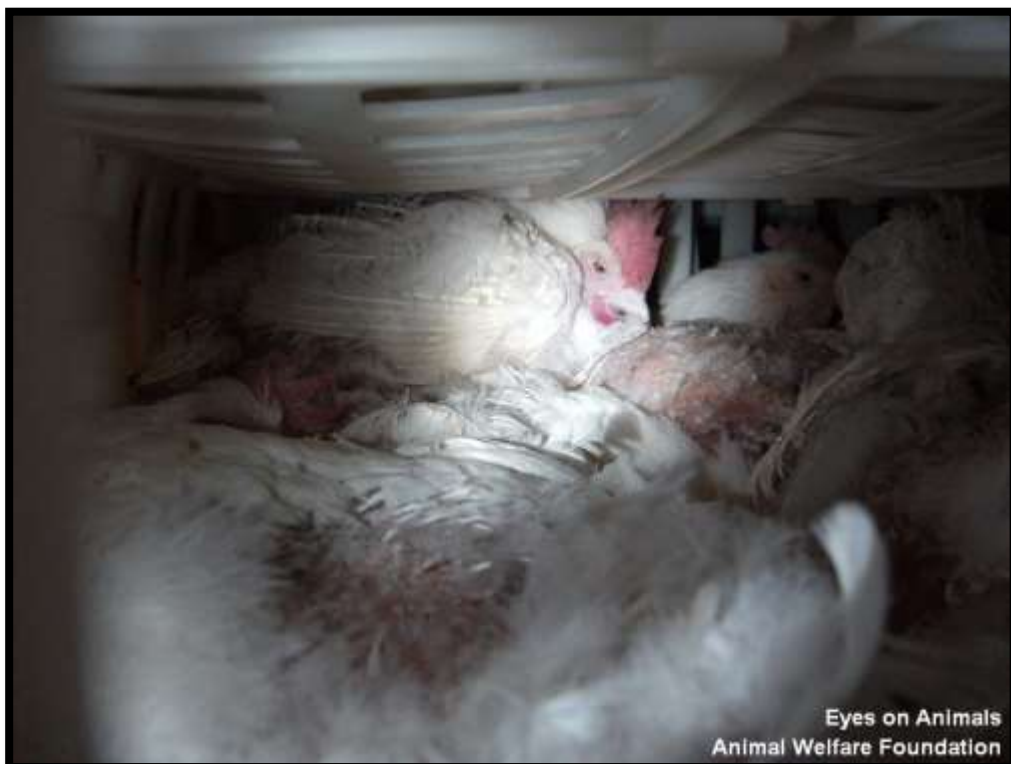
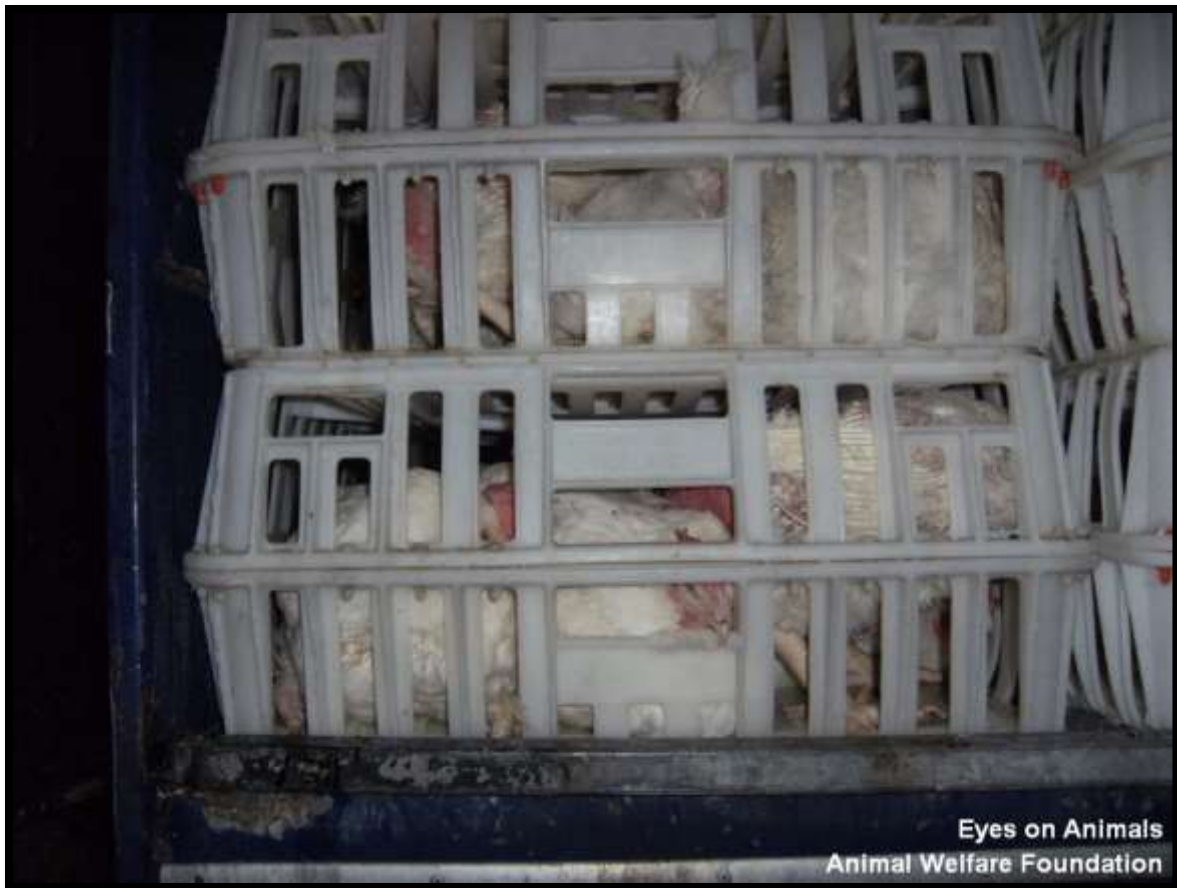
22:35 truck stops at a Texaco gas station on the A50. The young driver (son of mister Van der Berg) comes out to see us. We explain who we are and that we will trail him to document the welfare of the birds during the journey. We explain that we are also interested in the different designs of crates being used in practice. The crates cannot be seen due to the side tarps covering all of them. He kindly pulls open part of the side panels so we can check on some of the chickens on board, and the crates. The crates they use have sliding top doors to load the birds, which he feels is better than the doors that open upwards (us too). The crates look in good shape, we do not see any that are seriously broken. Nevertheless, the floors of the crates are bending down slightly under the weight of the birds and the headspace is very limited. There is also no access to the animals during transport. The photo below shows clearly that the birds cannot stand up in a natural position, and if they all did ventilation would be seriously impeded.

The man in the car that has been following us, is Mister Van der Berg. He approaches us too. He will take over driving from now on, his son will return home. Mister Van der Berg says that he has loaded 9 chickens per crate, and that each bird weighs around 3.5kg. We try to count, and think we see 10 but it is difficult to be certain as they are very tightly packed.

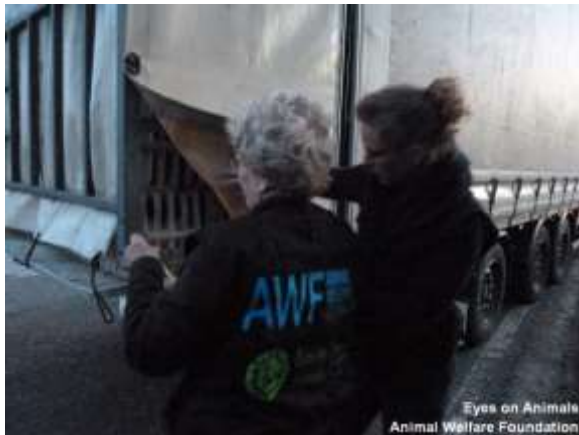
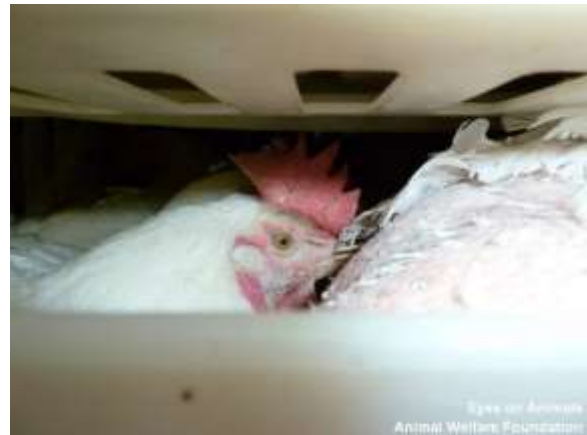
We check on the birds in the back bottom corner, as the wind-tarp is broken there so it flaps open. We do not see any serious injuries (no wings or feet caught, no dead birds). But they also look crowded and the headspace is restrictive.

We measure the crate – 60cm x 80cm x 30cm. We indeed count 10 birds, not nine. The available floor space is slightly less as they are diamond shape – estimate 74cm in length. Thus 60cm x 74cm x 30cm

Crate provides: (60cm x 74cm) 4440 cm² floor space / 10 birds x 3.5kg = 126,9 cm² each

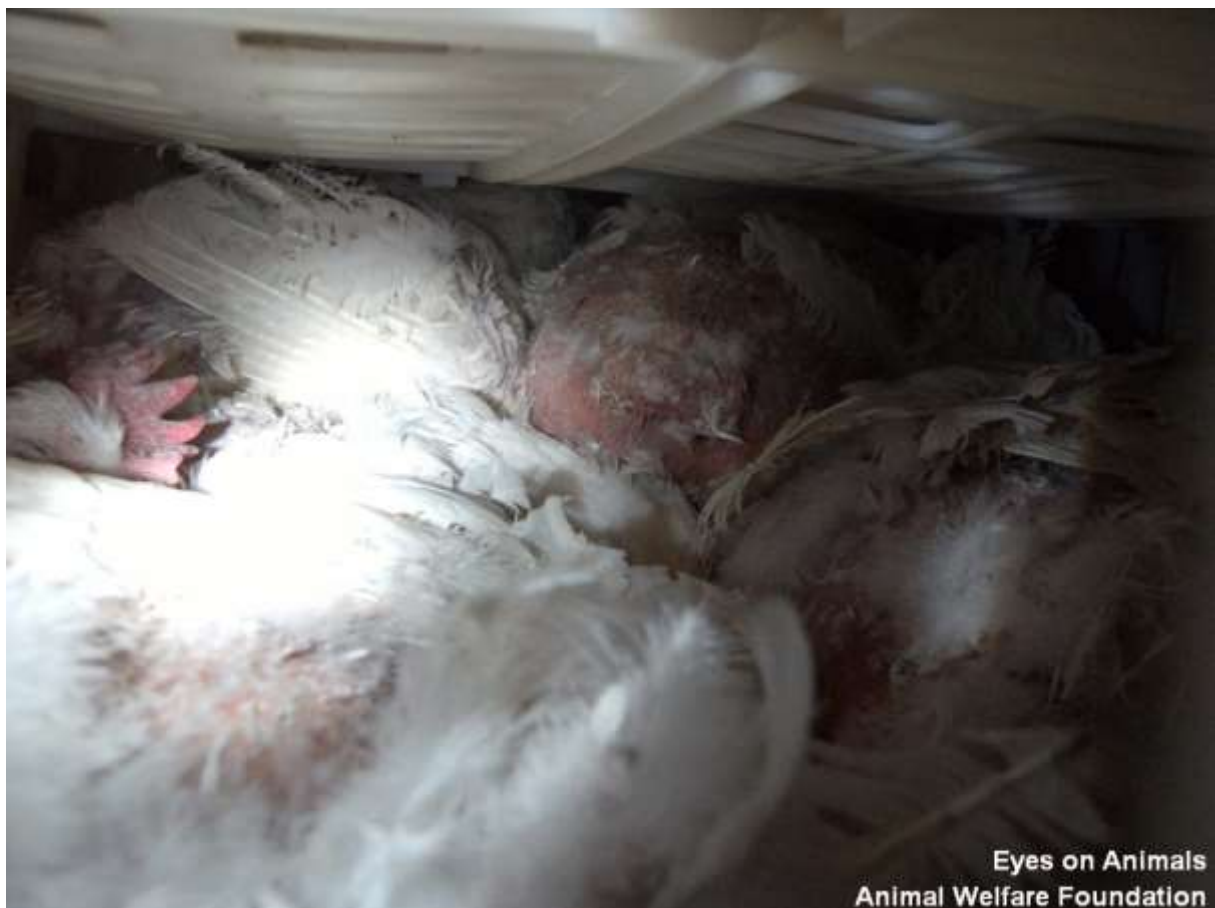
Thus EU maximum density was, **surprisingly**, respected. Photo below shows that the floor of the crates is bending from the weight of the birds above, further restricting ventilation and headspace.

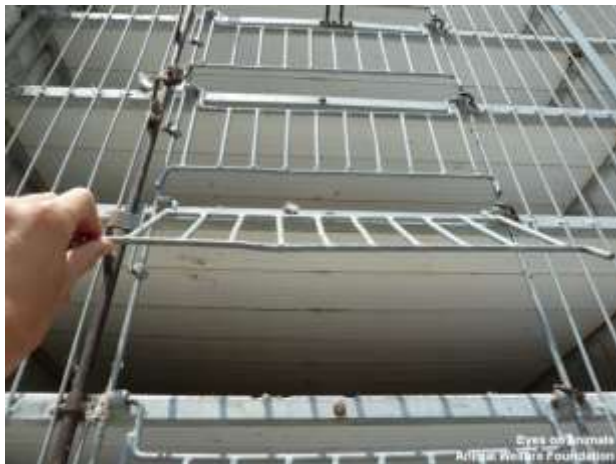
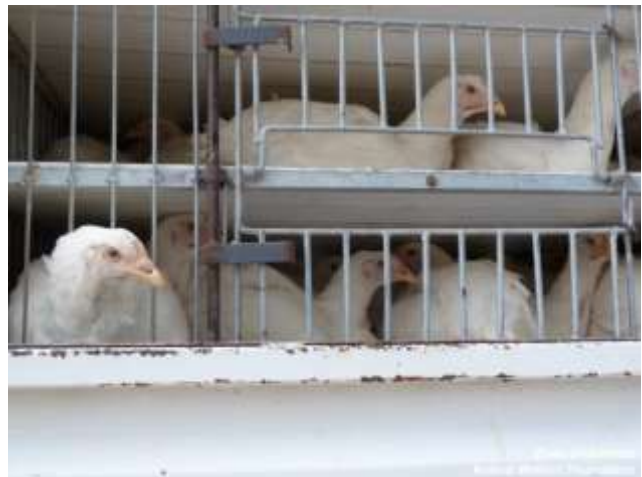
Access doors provide access to all birds in order to give first-aid or separate any that fall sick or injured during transport.

We are just in the beginning phase, but recently in Turkey a team from Eyes on Animals and Animal Welfare Foundation observed a truck with spent breeding birds going for slaughter and were very impressed. There were only two columns and each crate had an access door, meaning all birds could be accessed during transport, none were prisoners to their crate. A space of about 20-25 cm was left

empty between the two columns, to allow for adequate ventilation to all birds. The birds are also loaded from the side, not from small top-doors therefore avoiding the problem of some getting their wings, feet and even head caught during loading.

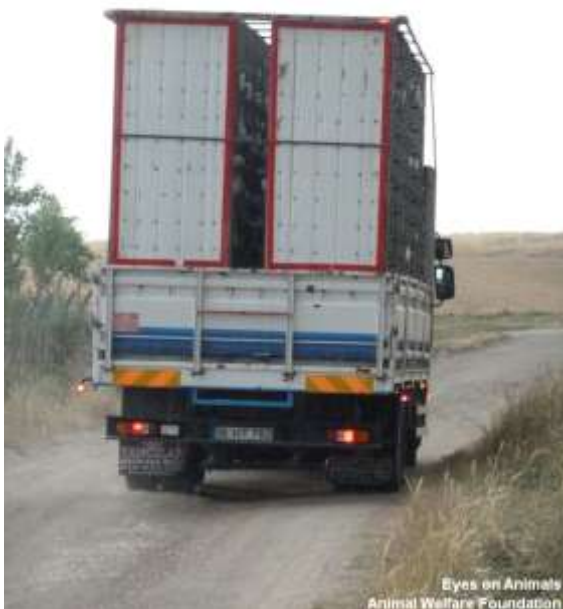
Having two columns with an empty space in between means much better ventilation for ALL birds and access to all (no more birds stuck in middle rows, with limited air and no access).¹
