Introduction

The 'Specific' Incident – Ramsgate, Kent, UK – 21/11/12

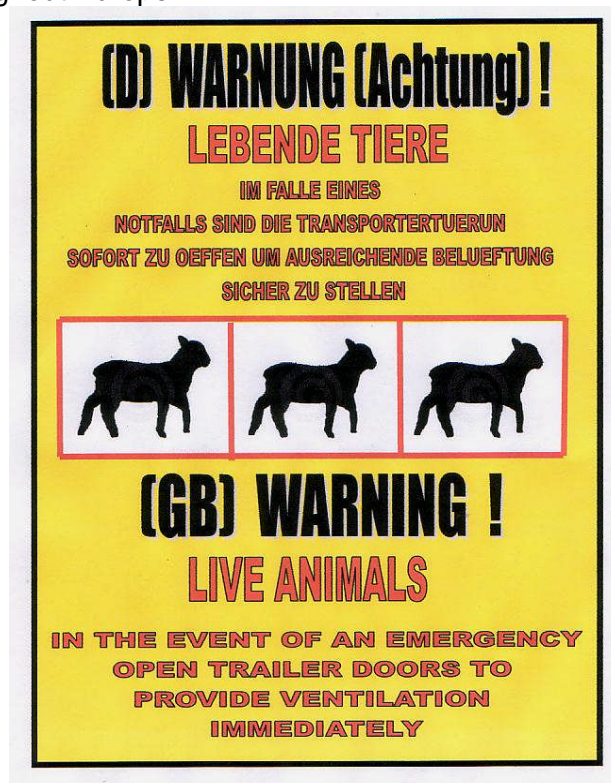
The following example graphic below shows what was presented as a draft suitable label in the letter from KAALE to Mr. Gavinelli on 7th February 2013. Note that in this example, the 'live animals' identification is written in both German and English languages. These were examples only for the production of this example graphic, and it was suggested to Mr. Gavinelli that maybe even three (3) 'prime' EU languages should be included onto each label. Sizes were not determined.

The example graphic below and as provided to the EU shows an ovine (sheep or lamb); but it was suggested to the EU Commission that this could easily be amended to show either pigs or cattle / calves if required. Whatever, a graphic showing the picture of a farm animal was suggested to Mr. Gavinelli for inclusion into amendments for Regulation 1/2005 re the labeling / signage of trailers carrying live animals throughout Europe.

Above - Example Graphic as presented by KAALE in their letter of February 2013 to the EU DG.

This is completely unacceptable under current circumstances, and we call for immediate changes to EU Regulation 1/2005 on the protection of animals during transport to ensure that clear and **permanent, non-removable signage is displayed** on both sides, the front and the rear, as well as the roof and underside of **ALL vehicles carrying live animals throughout the EU**.

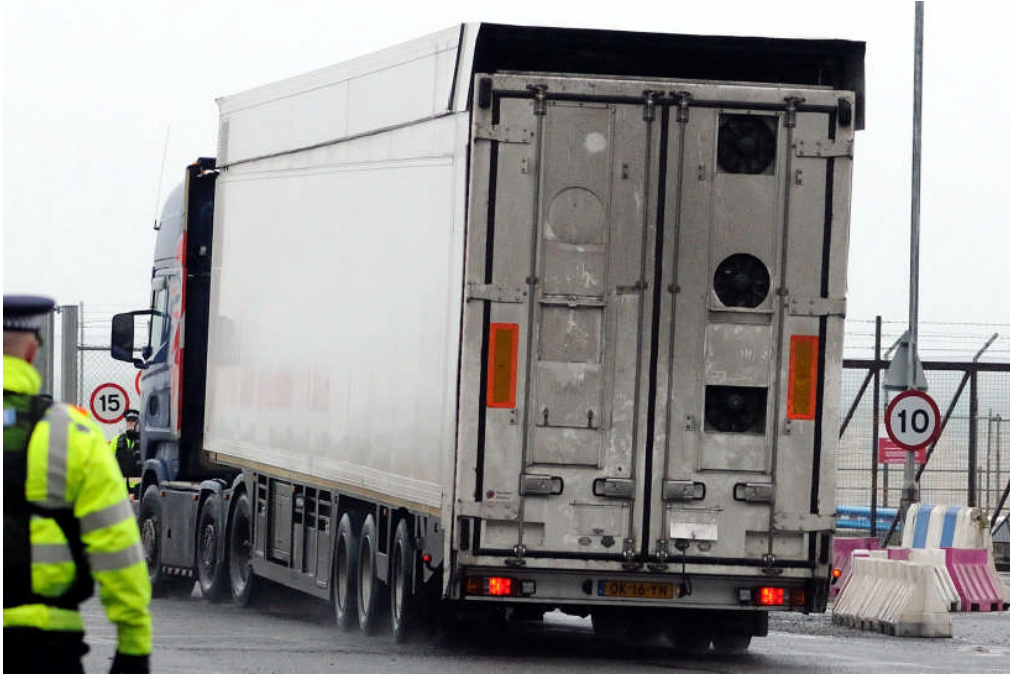
On the morning of Wednesday 21st November 2012, a Dutch registered livestock transporter (as shown in photograph No. 1 below); Registration: BZ HX 63 (front) / OK 16 YN (rear), arrived at Ramsgate harbour, Kent. It was totally obvious to all KAALE and other animal welfare monitors / observers at the port at the time, that this vehicle was NOT compliant with existing EU Regulation 1/2005 rulings; namely CHAPTER II – Means of Transport – 2. Additional provisions for transport by road or rail; sub para 2.1 **by NOT being**: “**clearly and visibly marked indicating the presence of live animals**”.

Photo 1 - Dutch registered livestock transporter, Registration: BZ HX 63 (front) / OK 16 YN (rear), arrives at the entrance to Ramsgate harbour, Kent on the morning of Wednesday 21st November 2012.

In their FoI application, KAALE questioned AHVLA that from their (KAALE) photographs, as shown in Photo 1 on page 3, there were **NO clear and visible markings carried by the vehicle indicating the presence of live animals** being carried on the vehicle that morning when it arrived at Ramsgate.

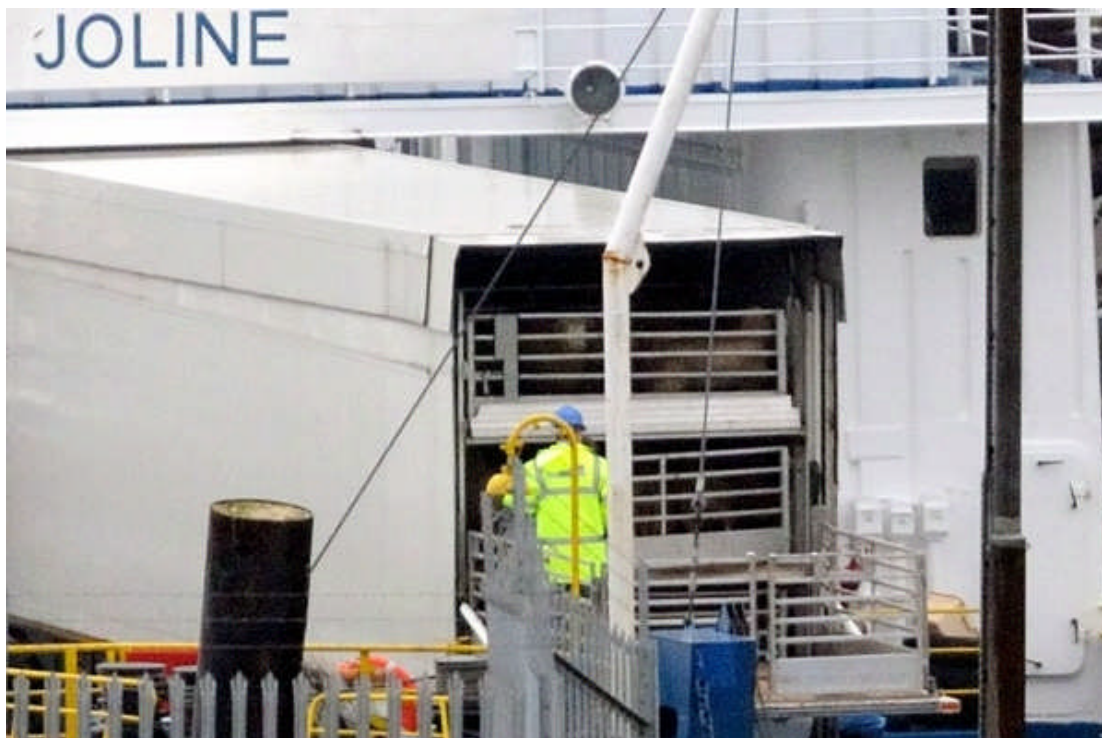
It needs to be made clear at this point that **this inspection** of the trailer and the animals contained within **was undertaken when the livestock carrying vehicle HAD LOADED onto the vessel 'Joline', and not before whilst it was still within in the harbour compound.** This can be clearly seen in the KAALE photograph number 2 below which identifies that the trailer was inspected **once it had boarded** onto the 'Joline'. The animals on board the transporter were Ovines, or sheep.

Photo 2 – AHVLA inspection of the ovines (sheep) carried in the trailer are undertaken only once the vehicle has boarded onto the vessel 'Joline'; as the blue (vessel) name sign clearly indicates.

There can be no denying that from the photographic evidence obtained by Valerie Cameron and presented in 'Photo 2', that on the day, an inspection did take place by AHVLA inspectors; but that this was undertaken on board the 'Joline' vessel and not within the harbour compound area. KAALE do not question this point and we also believe that the official 'UK competent authority' (AHVLA) inspectors were fully aware of the standard of the trailer, including the obvious fact that live animals (Ovines) were being transported. This is verified by our photographs.

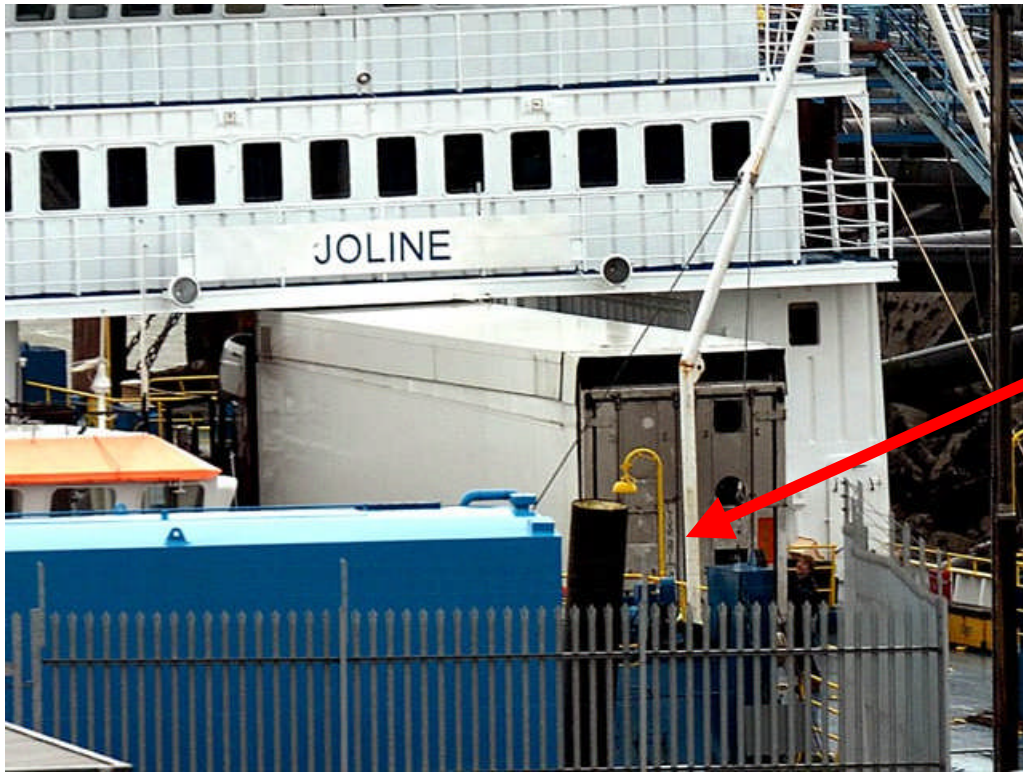
Photo 4 – KAALE image of the vehicle loaded onto the vessel 'Joline' – and as correctly stated by AHVLA in their letter, the 'LIVE ANIMALS' signage is clearly visible (see red arrow).

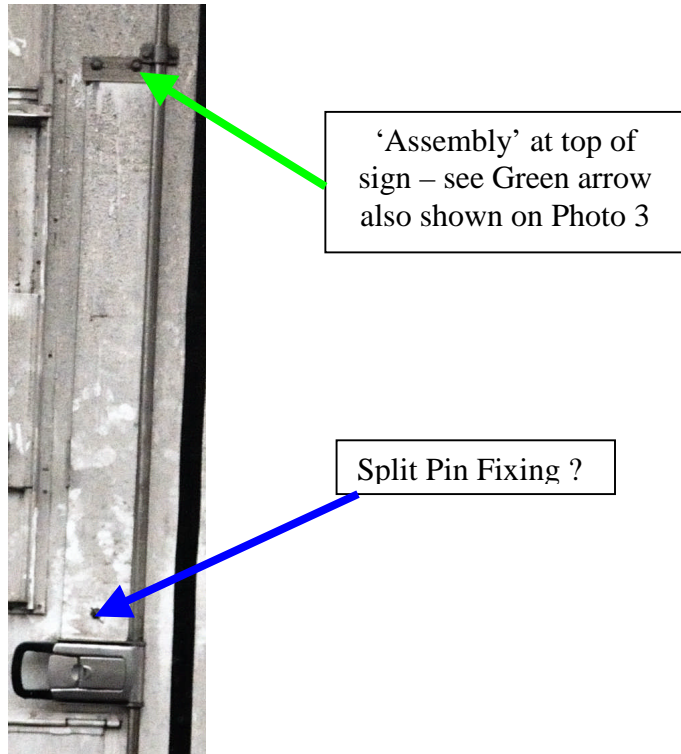
It appears to be a small location plate held in position on the rear left door of the trailer by two simple fixings. And what else do we see? – could this be a **white metal plate the entire length and width of the 'LIVE ANIMALS' sign which was SO visible at inspection time on the 'Joline' ?** – possibly held in position at the bottom by a single split pin device for quick removal?

Photo 5 - Small plate completely covering the 'LIVE ANIMALS' signage, and held in position on the rear left door by a simple fixing at the top (green arrow) and a split pin device at the bottom (blue arrow).

Now let's go back to 'Photo 5' above – are there some human hand prints shown in the dirt on this blanking plate ? – a plate which must have been handled very recently we suggest, considering the untouched dirty areas on the majority of the rest of the trailer doors. Maybe the handling was done after animal loading when the sign was visible ?

- Once the original loading had been completed and the supervising personnel for this procedure had departed, or the vehicle took to the road for the first lay-by or services, is it possible that a white metal plate was suddenly located into our 'assembly' (see photos 3 and 5) at the top of the sign (Green arrows), given a 'good thump' (as shown by the palm prints in the dirt on the photo 5) and then simply secured by the split pin fixing (blue arrow) at the bottom ? – thus **completely covering** the signage indicating that 'LIVE ANIMALS' were being carried ?

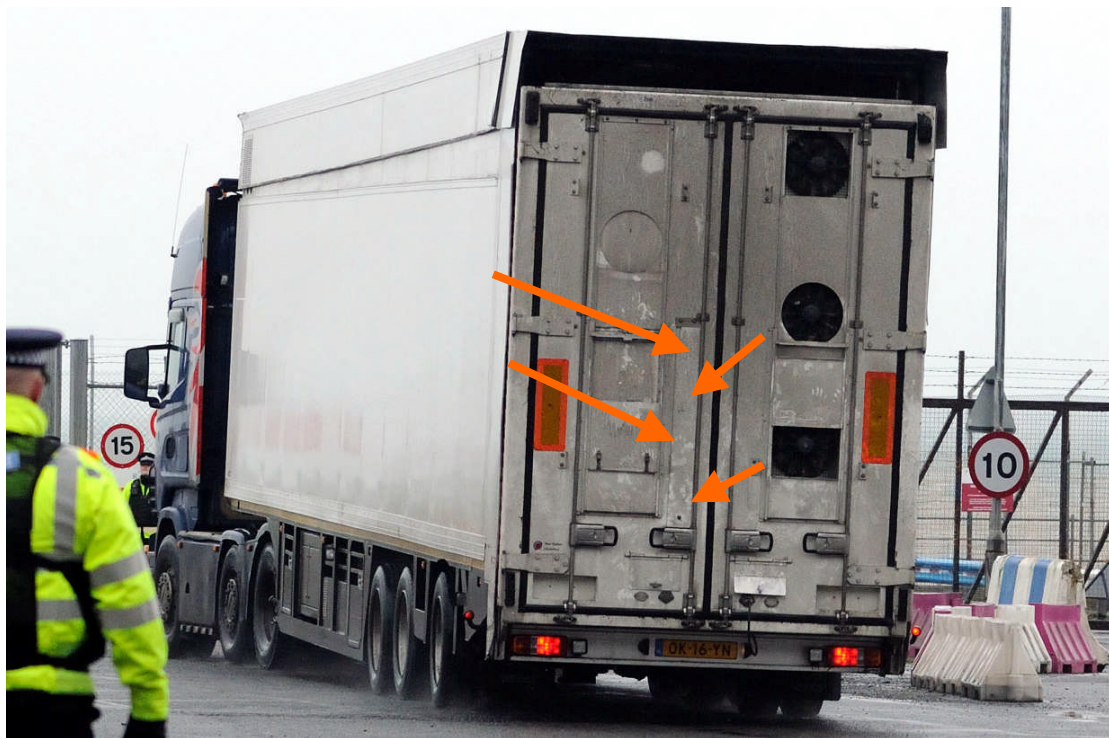
Lets now look at the Ramsgate harbour vehicle arrival photograph (Photo 1) taken by Valerie once again, showing the area in photos 4 and 5, identified below by orange colored arrows:

It certainly looks to us as if the white metal plate **has been located directly over the 'LIVE ANIMALS' signage which was seen and verified at original animal loading**; thus rendering it not visible to anyone 'on the road' between the original loading point up until arrival at Ramsgate harbour. Where it suddenly re-appears on the 'Joline' prior to AHVLA inspection. See orange arrowed section.
