Export of sheep from the UK to Germany

23-24 August 2016

Inspection by Eyes on Animals

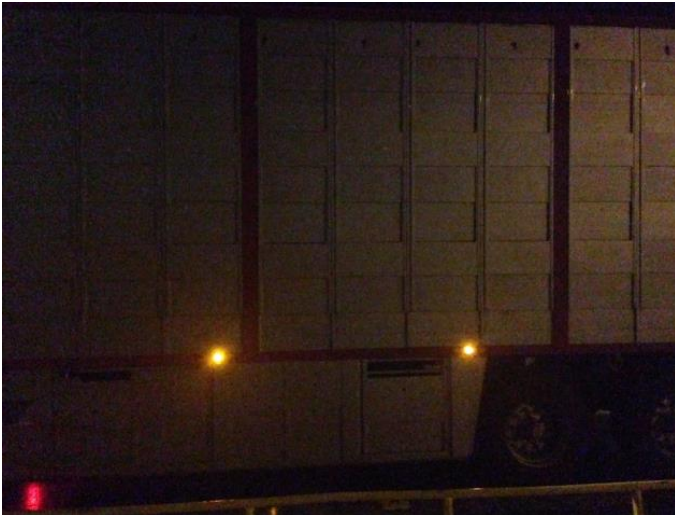
Nicola took some photos of the Smilde truck, whilst it is still onboard the Joline. The driver then decides to put the slats up.

Slats up at Smilde truck

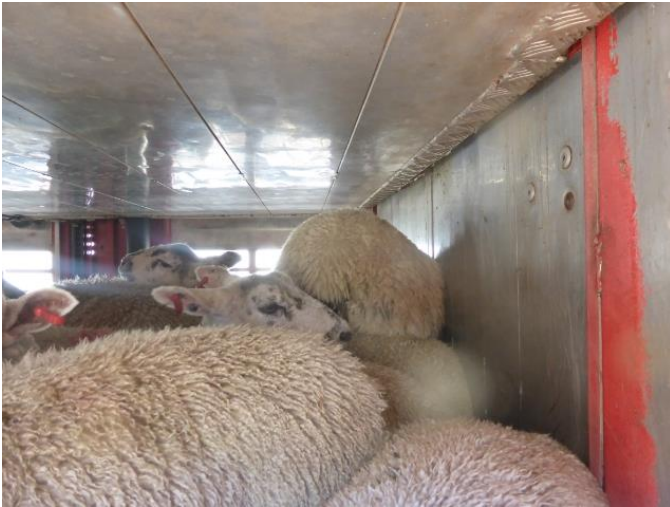
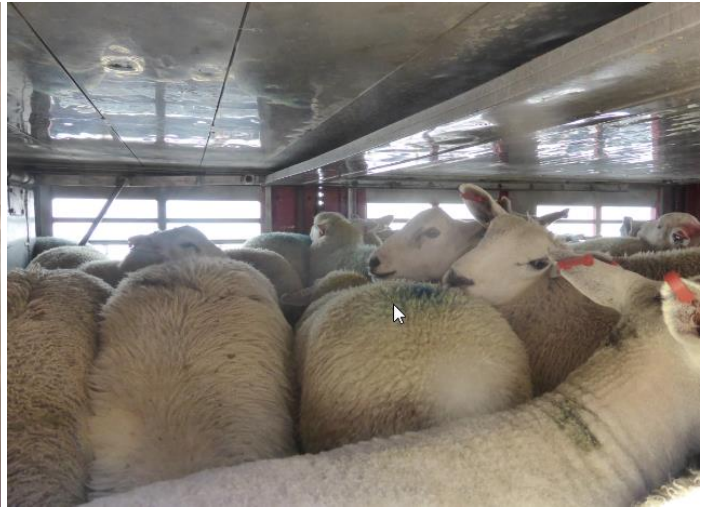
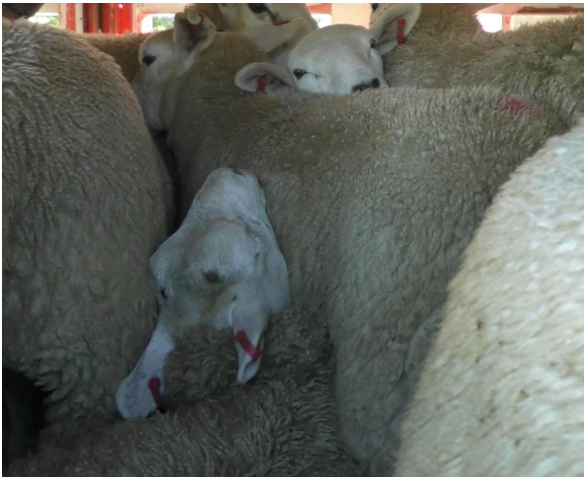
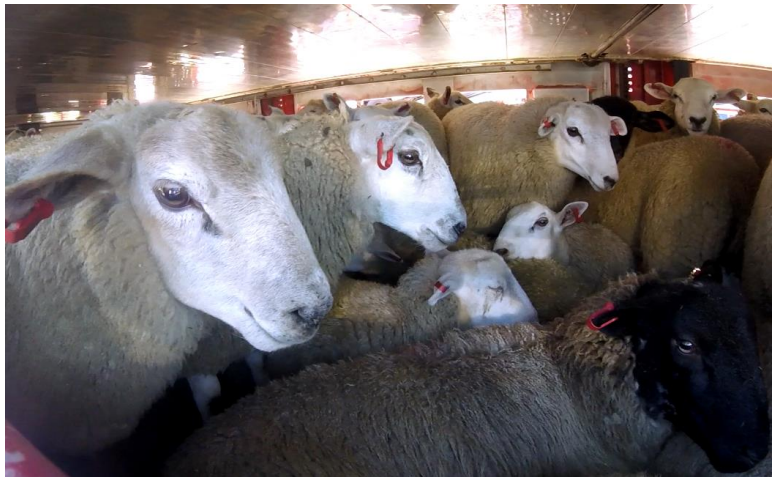
Loading conditions

We observed that all of the livestock trucks coming from the UK, including the one we trailed from Diepeveen, had too high loading densities. The sheep often had to step on top of each other and could not all lie down at the same time. Ones that were lying were often trampled by others. We also observed that most sheep were not shorn recently. Some had a really big fleece and others a medium fleece.

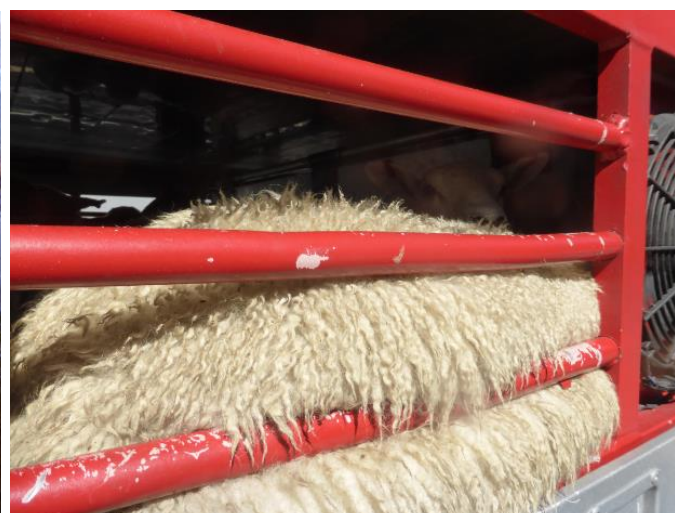
Most sheep had their fleece

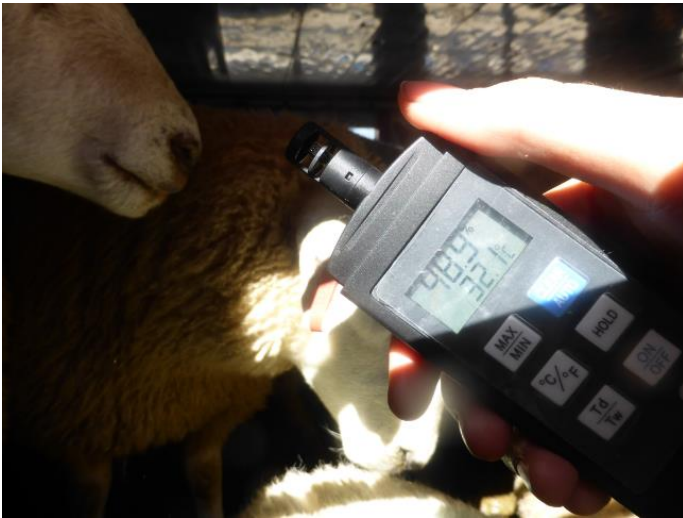
On the side where the sun shines directly into the truck it is 32.1 degrees Celsius and a humidity level of 48.9. On the other side it is 30 degrees Celsius with a humidity level of 43.9.

Temperature measurements inside the truck around 12:10.

During our inspection measurements were taken inside the truck at 12:10 of 32.1 degrees Celsius with a humidity level of 48.9. This means that the animals were in a danger zone. We saw sheep breathing rapidly and ones showing lethargic behavior. We could only measure the temperature in the lower tier. Because heat rises, it is possible that temperatures were even higher in tier two and three.

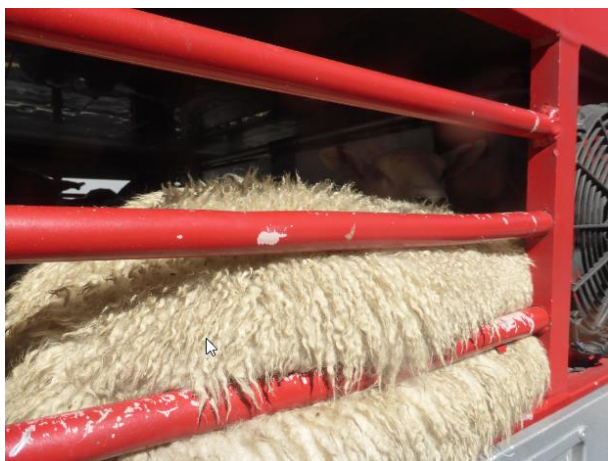
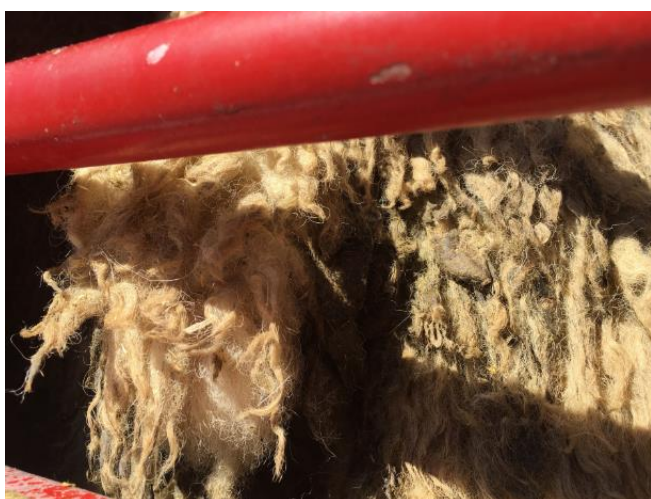
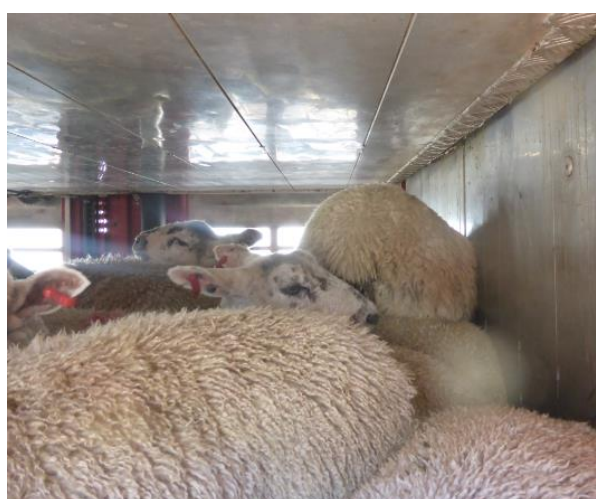
Many sheep still had their fleece

According the journey log and inspection reports Diepeveen transported 417 sheep. The average weight of a sheep was 35kg. The truck had a total floor area of 89.45m² and each sheep was given 0.20-0.22 m² only. This means loading density was based on shorn sheep while according our observations most of the sheep on board were clearly unshorn.
