## **Inspection with Polish authorities of a poultry truck with spent- laying hens from the Netherlands**

**Date:** 20.04.2016

**Location:** A2 highway near Poznan, Poland

Poultry- truck owned by Zakład Drobiarski „Lech Drób” Sp. z o.o.;  
Registration number: NIL 28211,  
Make: Wielton.

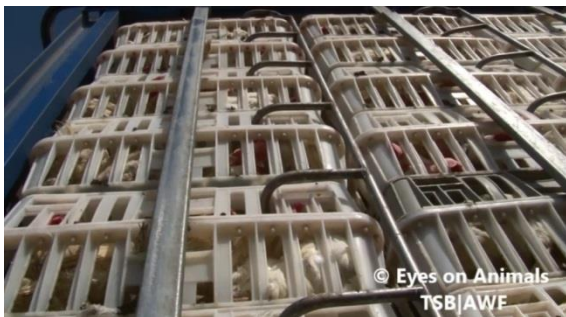
A generally modern truck with watering system for poultry. We could only see the watering system for external rows of cages, the drivers said there is a watering system for the middle row as well. Unfortunately, after asking the drivers to turn the water on, we saw that the watering system on the right side was leaking at about two thirds of the length of the truck, which means that birds in the back one third of the truck were transported without water supply. (see video footage).

Cages appeared overcrowded with birds. We see many dead ones. Water system leaking.
